Inspection #0001015

Date of Inspection: 11/15/2007

# Visual Home Inspection Report

101 Main Street, Eureka, CA

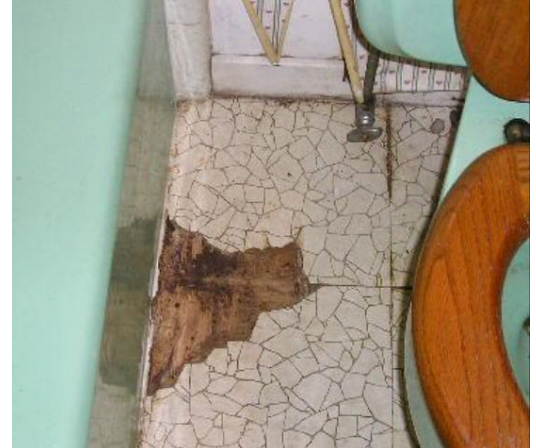
ACTION ITEM: Staining/discoloration and deterioration was noted near the toilet, which is likely due to moisture intrusion. Recommend further evaluation and repair as required by a qualified tradesperson.

**ACTION ITEM: Staining/discoloration and deterioration was noted near the toilet, which is likely due to moisture intrusion. Recommend further evaluation and repair as required by a qualified tradesperson.**

**Bathroom floor damage**
